DISCOVERING ROCKS OFF LABRADOR: A Photo Essay

David H. Gray

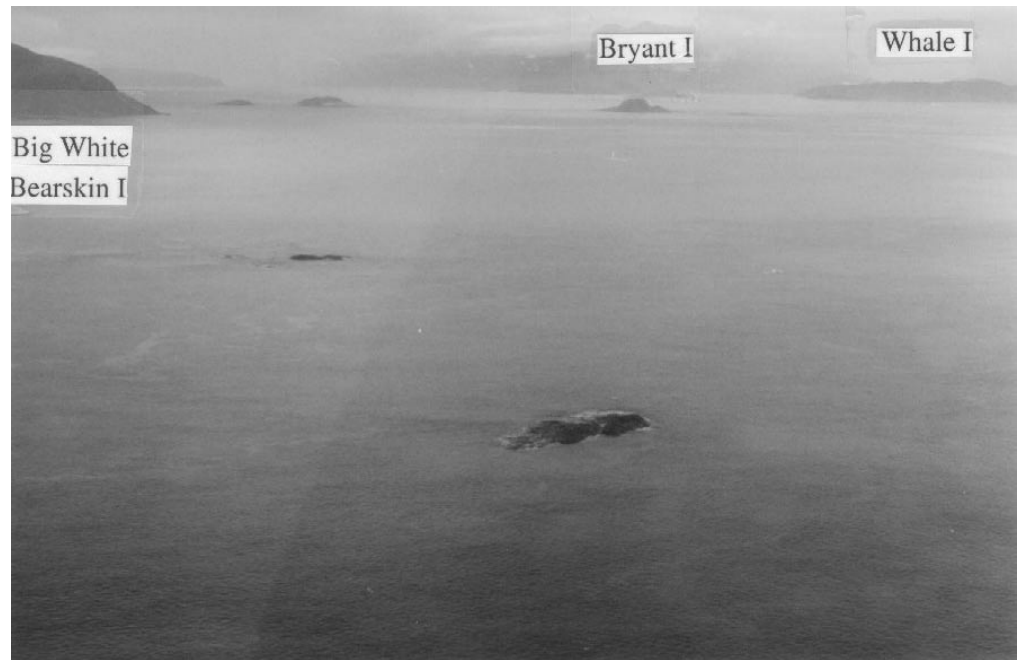
Figure 2. Unnamed rock east of Big White Bearskin Island ($59^{\circ} 21' 54''\text{N}$, $63^{\circ} 25' 22''\text{W}$) as photographed and positioned by GPS in 1997. In 1973, this rock was also positioned by angles and distances of an electronic distance measurement traverse. It is 1.1m above high water.

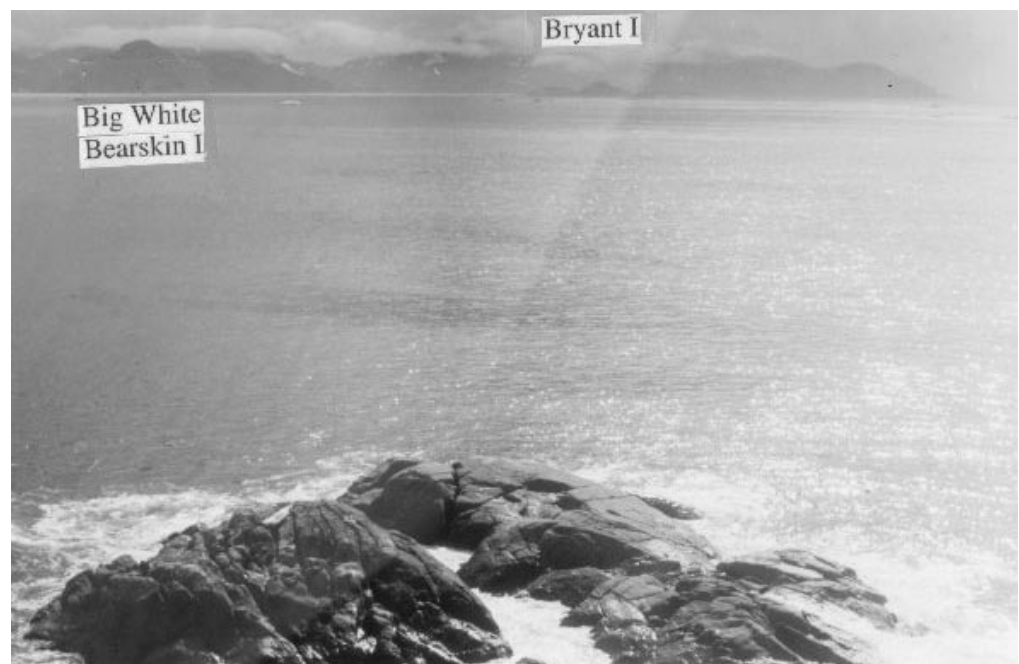
Figure 3. Unnamed rock east of Whale Island ($59^{\circ} 26' 52''\text{N}$, $63^{\circ} 28' 55''\text{W}$) as photographed and positioned by GPS in 1997. It was charted 300m from where it was found, but was not identified in the aerial photography. It is estimated to be 2m above high water.

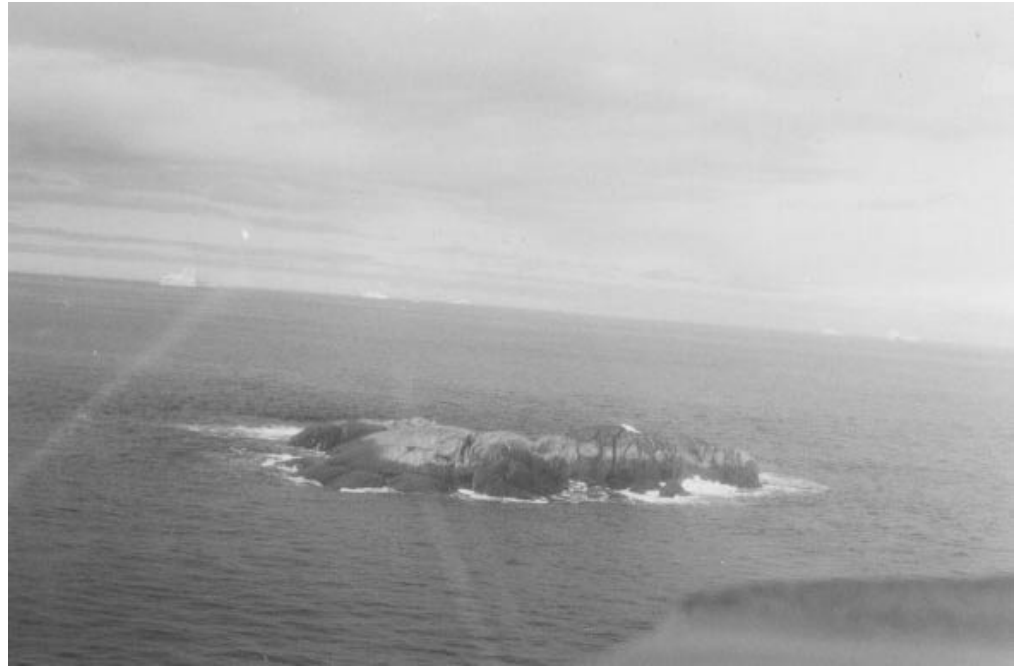
Figure 4. Same rock as Figure 3. Because helicopter flight happened to occur near the time of low tide, the high water line is clearly visible in this photo. Note the white piece of flotsam on the rock that is also visible in Figure 3.

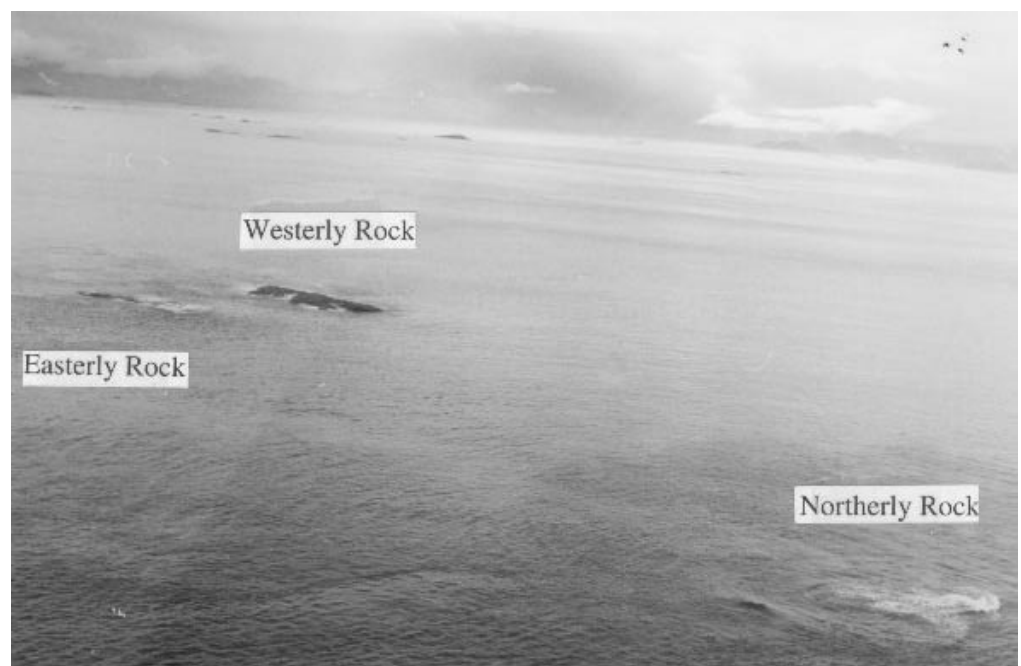
Figure 5. Three unnamed rocks east of Murphy Head. The westerly rock was seen in the airphotos and satellite imagery and had been surveyed as 1.9m above low water. The northerly one was seen only in the airphotos. It is located at 59° 30' 30"N, 63° 31' 27"W and is 0.9m above low water. The easterly rock was not seen in the airphotos or satellite images, but found during this survey to be at 59° 30' 17"N, 63° 31' 24"W and 1.2m above low water.

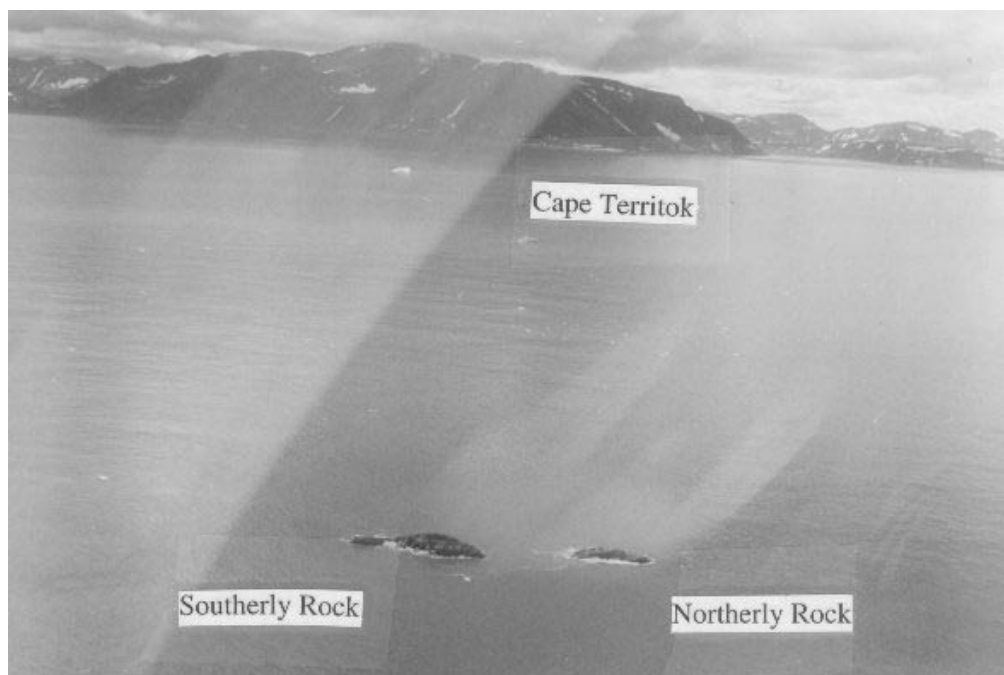
Figure 6. Two unnamed rocks east of Cape Territok. The southerly rock was part of an EDM traverse in 1973 and is 2.0m above high water. The northerly one is located at $59^{\circ} 43' 45''\text{N}$, $63^{\circ} 43' 28''\text{W}$ and is 0.5m above high water.

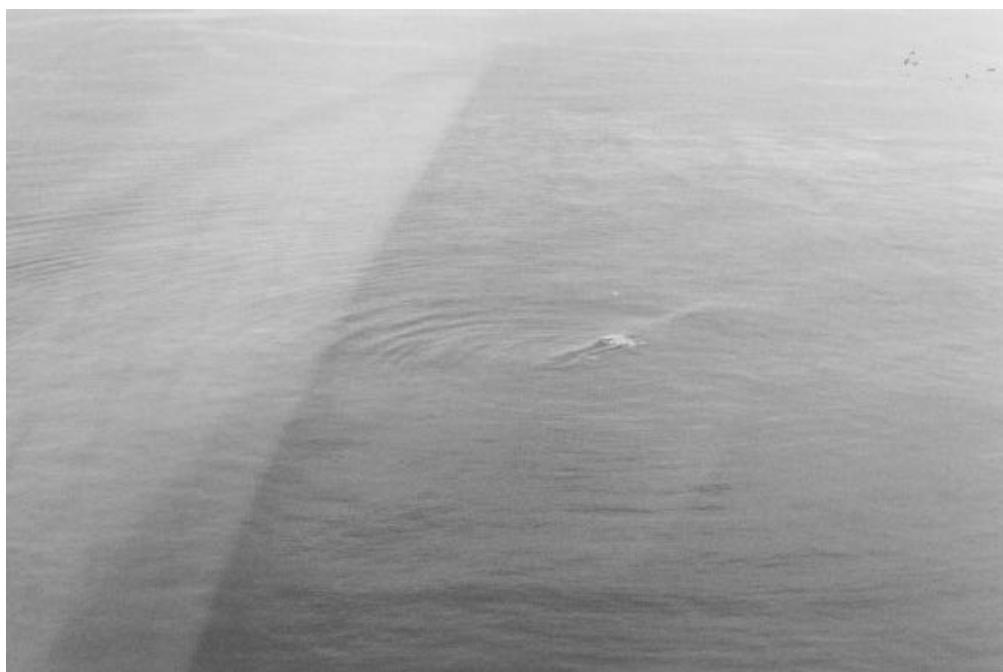
Figure 7. Unnamed rock east of Cape Territok. The rock was shown on a 1973 field sheet but with no recorded depth or height. It was not spotted in airphotos or satellite imagery. The GPS position of the rock is $59^{\circ} 45' 18''\text{N}$, $63^{\circ} 40' 07''\text{W}$, which is about 575m west of the field sheet position. The rock is 0.5m above low water.

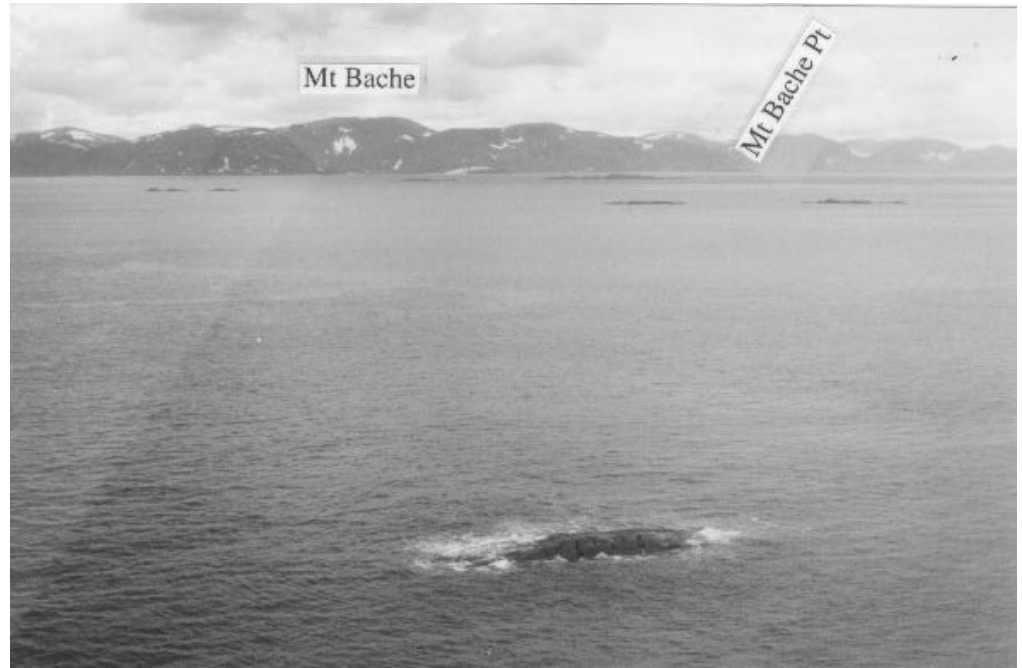
Figure 8. Unnamed rock on the east side of the Galvano Group. The rock was shown on a 1973 field sheet but with no recorded depth or height. It was not spotted in airphotos or satellite imagery. The GPS position of the rock is 59° 55' 19"N, 63° 50' 58"W, which is about 125m east of the field sheet position. The rock is 2.0m above low water.

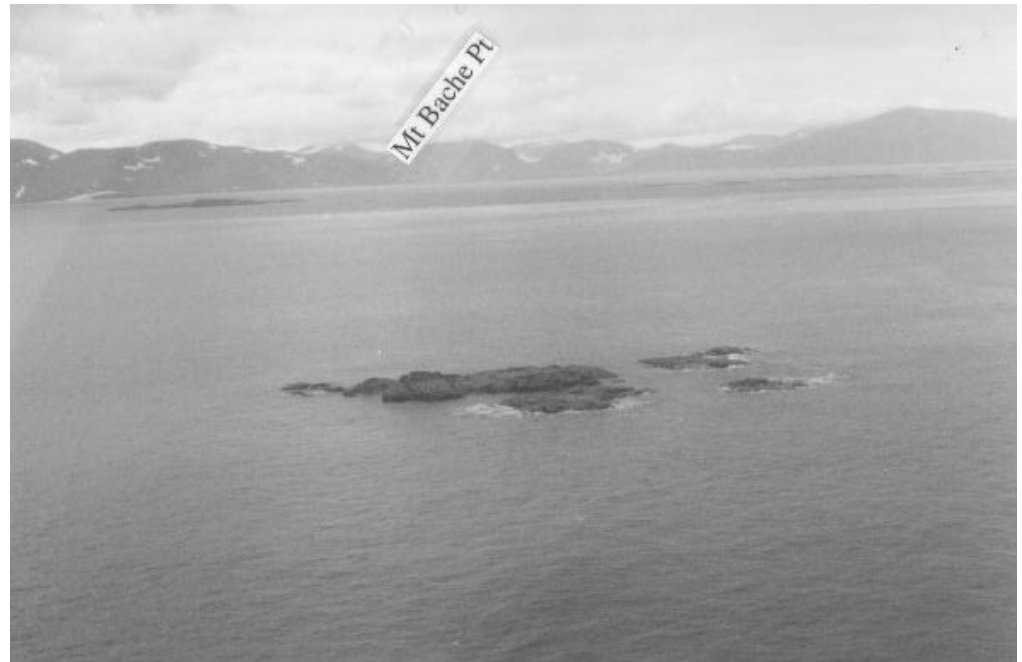
Figure 9. Unnamed rock on the east side of the Galvano Group. The rock was spotted in airphotos. The GPS position of the rock is 59° 55' 30"N, 63° 52' 55"W, which is about 430m north of the uncontrolled airphoto mosaic position. The rock is 0.5m above high water. Note the common islands in the middle distance 'moving' relative to the hills in the background of Figures 8 and 9.

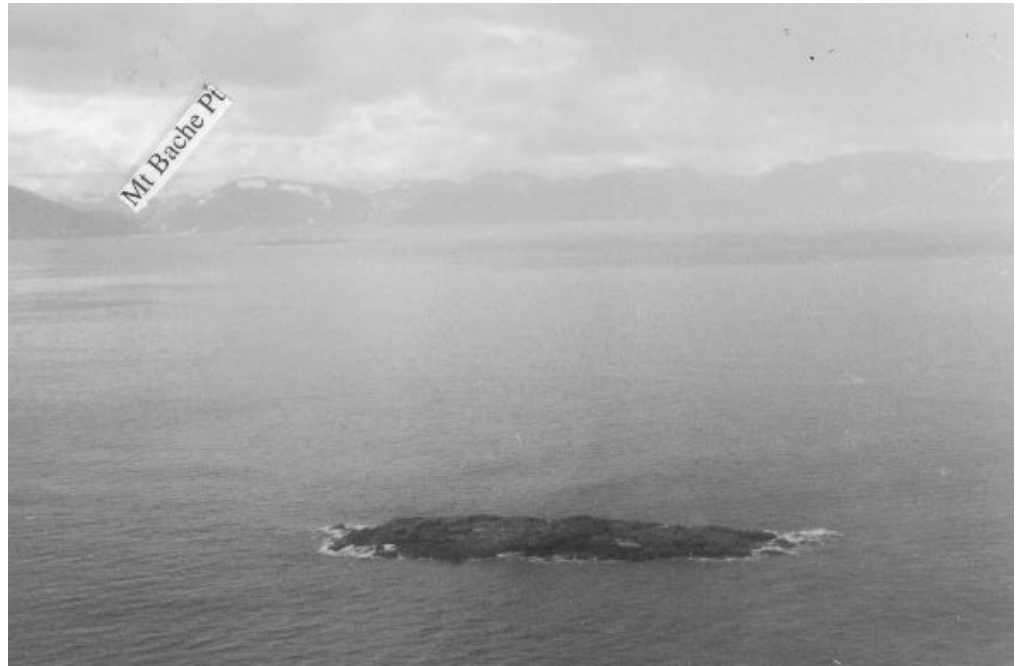
Figure 10. Unnamed rock on the east side of the Galvano Group. The rock was spotted in airphotos. The GPS position of the rock is 59° 57' 08"N, 63° 53' 01"W, which is about 30m northeast of the 1973 field sheet position. The rock is 0.5m above high water.

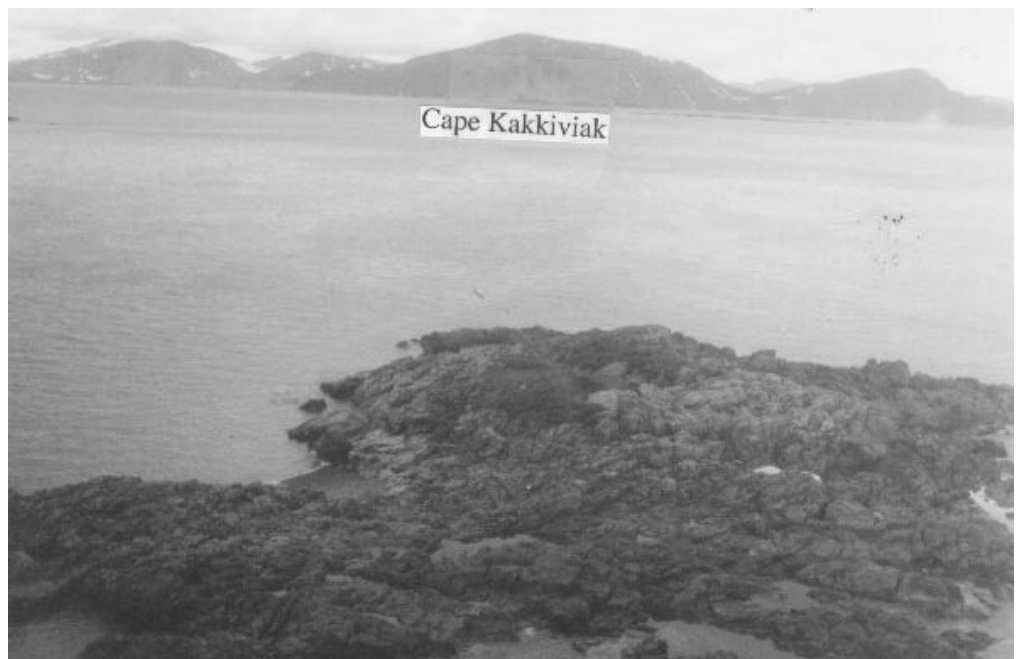
Figure 11. Unnamed rock east of Cape Kakkiviak. The rock was spotted in airphotos. The GPS position of the rock is 59° 57' 59"N, 63° 55' 13"W, which is about 560m north of the uncontrolled airphoto mosaic position. The rock is 3.5m above high water. Vegetation was growing on the rock.

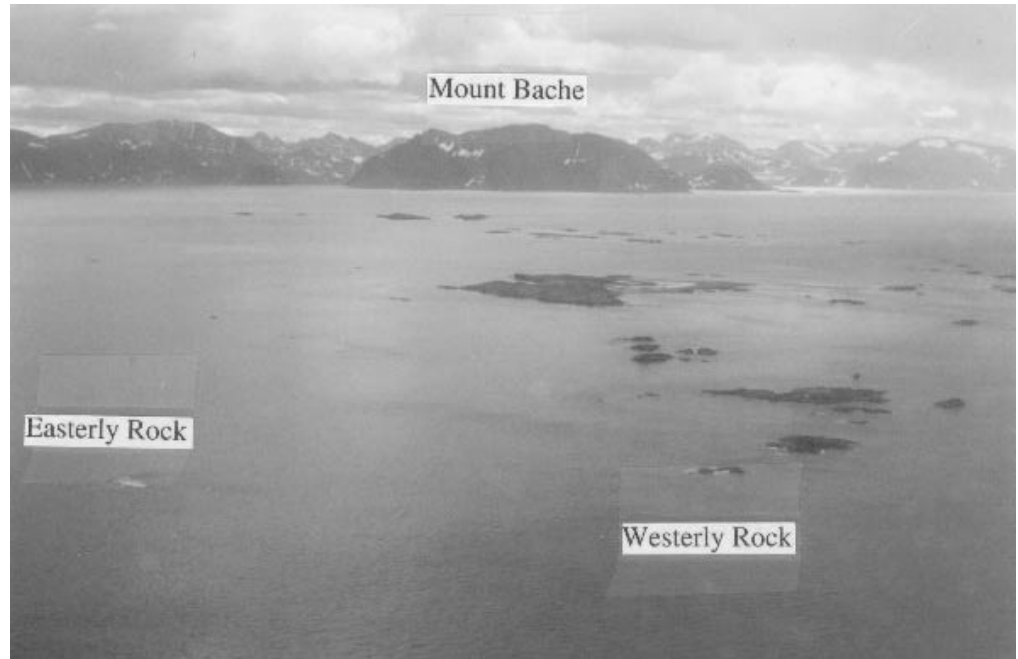
Figure 12. Two unnamed rocks east of Cape Kakkiviak. Neither rock was spotted in airphotos; but rocks to the southwest of the westerly rock were. The GPS position of the easterly rock is $59^{\circ} 58' 03''\text{N}$, $63^{\circ} 54' 30''\text{W}$, and is 0.8m above low water. The GPS position of the westerly rock is $59^{\circ} 58' 08''\text{N}$, $63^{\circ} 54' 52''\text{W}$, and is 1.4m above low water.

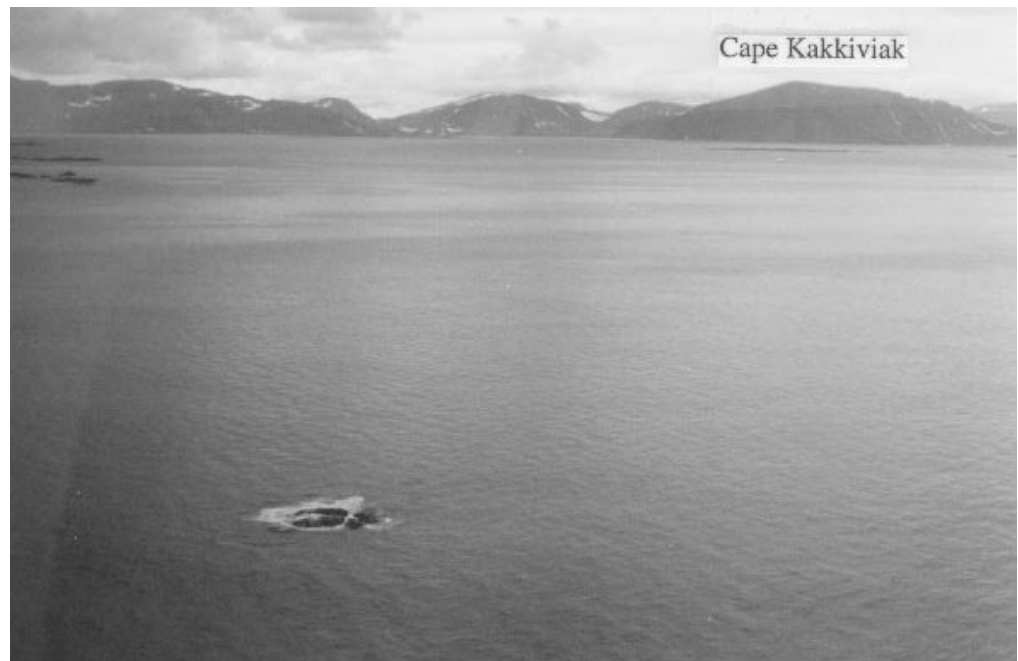
Figure 13. Unnamed rock east of Cape Kakkiviak. The rock was not spotted in airphotos. The GPS position of the rock is $59^{\circ} 58' 30''\text{N}$, $63^{\circ} 52' 59''\text{W}$, and is 1.1m above low water. The GPS position is about 610m north of the uncontrolled airphoto mosaic position.

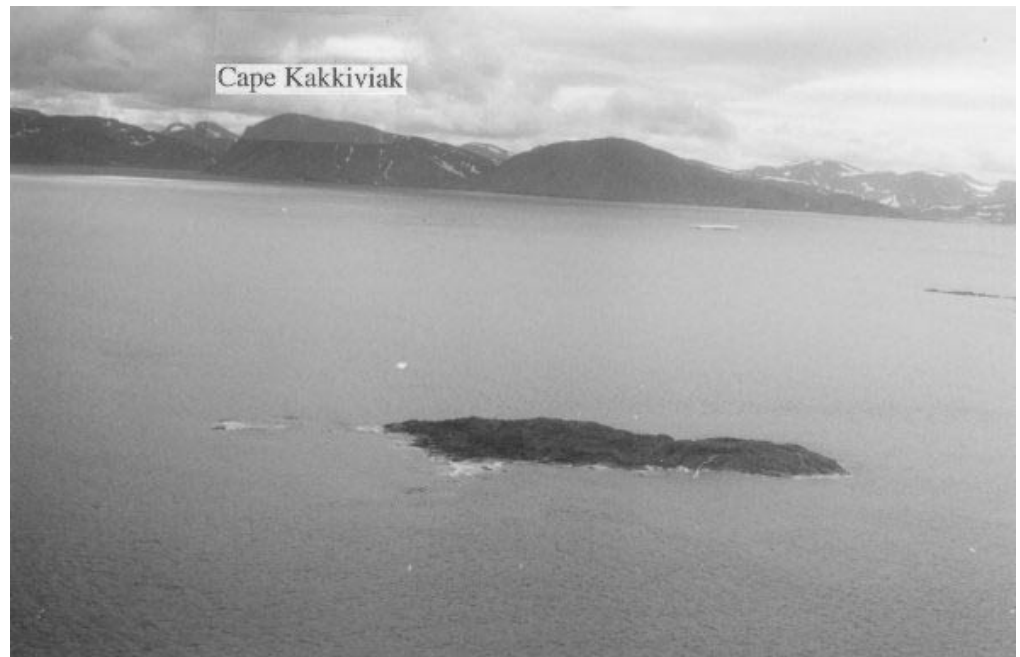
Figure 14. Unnamed rock northeast of Cape Kakkiviak. The rock was spotted in airphotos. The GPS position of the rock is 60° 04' 32"N, 63° 59' 13"W, and is 3.5m above high water. The GPS position is about 200m northwest of the uncontrolled airphoto mosaic position.

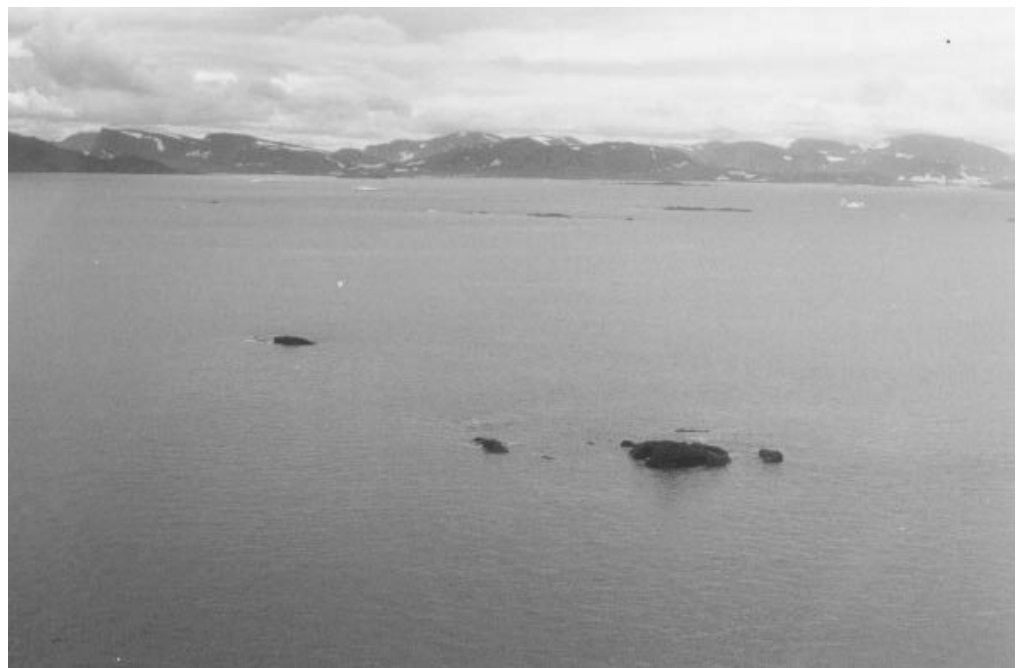
Figure 15. Unnamed rock east of Home Island. The rock was spotted in airphotos. The GPS position of the rock is 60° 06' 53"N, 64° 00' 55"W, and is 2.0m above high water.

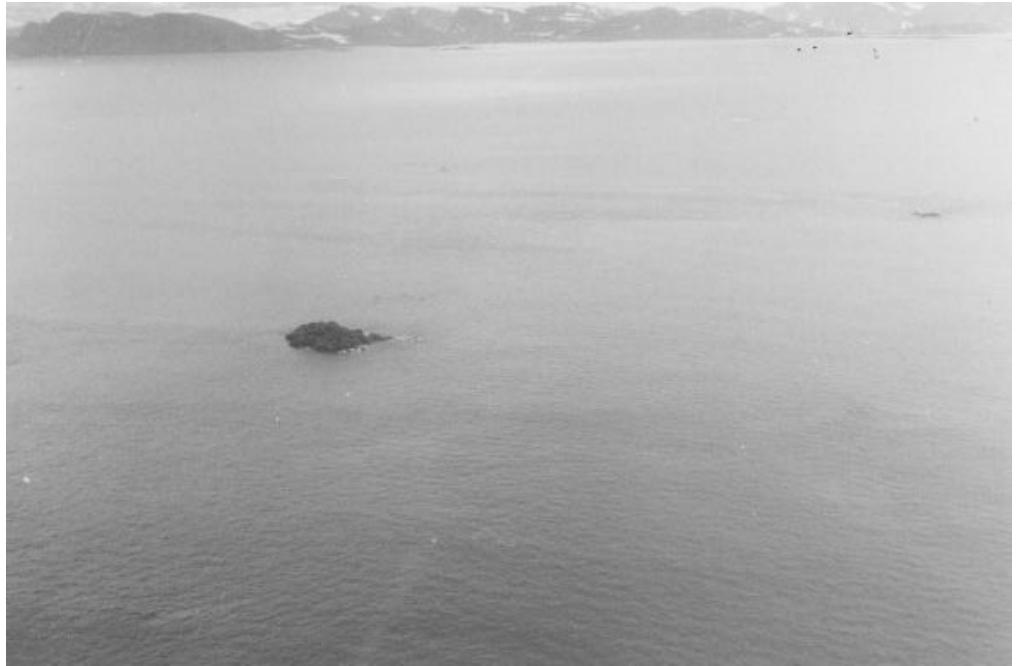
Figure 16. Landsat Island. The rock was spotted in satellite imagery in 1973, positioned in 1976 by sextant resection angles between distant hill tops. The GPS position of the island is $60^{\circ} 10' 37''\text{N}$, $64^{\circ} 02' 30''\text{W}$, and is 6.6m above high water. The GPS position is 70m east of the resection position. The rock, to the north was not seen in the 1973 imagery, the 1976 field work, nor the 1996 airphoto analysis but only during the 1997 survey. Even then, it was only because the survey was done at low tide. Its GPS position is $60^{\circ} 10' 47''\text{N}$, $64^{\circ} 02' 36''\text{W}$, and its height is 0.8m above low water.

The capability to detect anything is obviously in proportion to its physical size. An object less than one pixel size will likely go undetected, something the size of one or two pixels may well be missed and it may take an object the size of several pixels before identification is guaranteed. In 1976, Landsat Island was discovered by satellite imagery and hydrographic surveys in 1976 determined that it measured 45 by 25 metres. This gives some idea what is capable through satellite imagery.

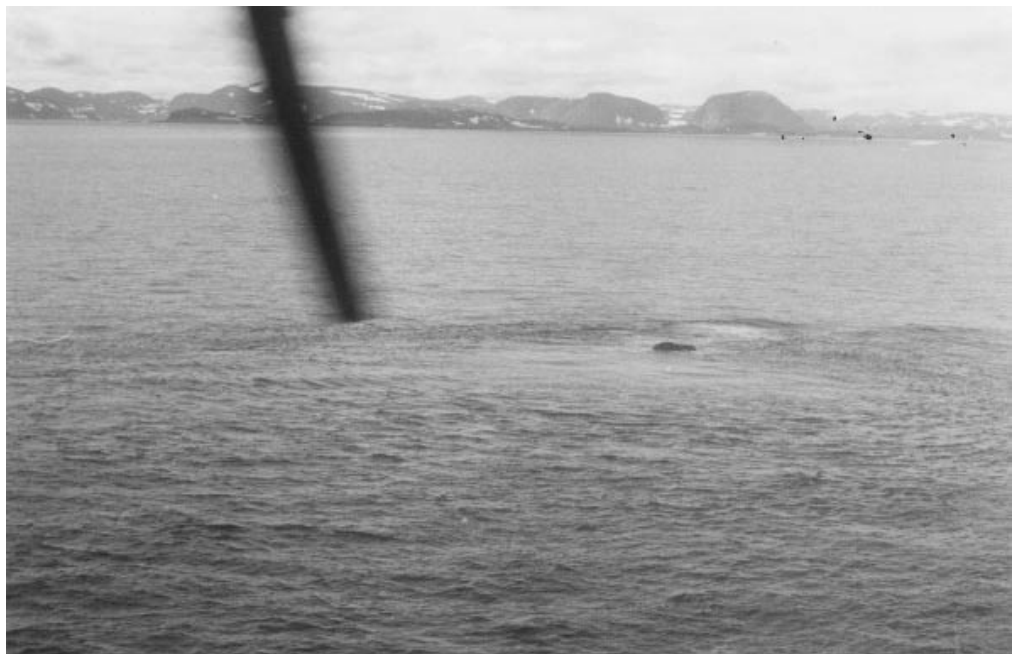
Figure 17. Rock north of Landsat Island. The photograph was taken after hovering over the rock for a minute while GPS readings were taken. The effect of the 'wash' from the helicopter's rotors is plainly visible.
